GATES POLY CHAIN CARBON and AIR COOLED HEAT EXCHANGERS

PRODUCT APPLICATION NOTES

Primary Causes of Synchronous Belt Failures (Part 1 of 4)

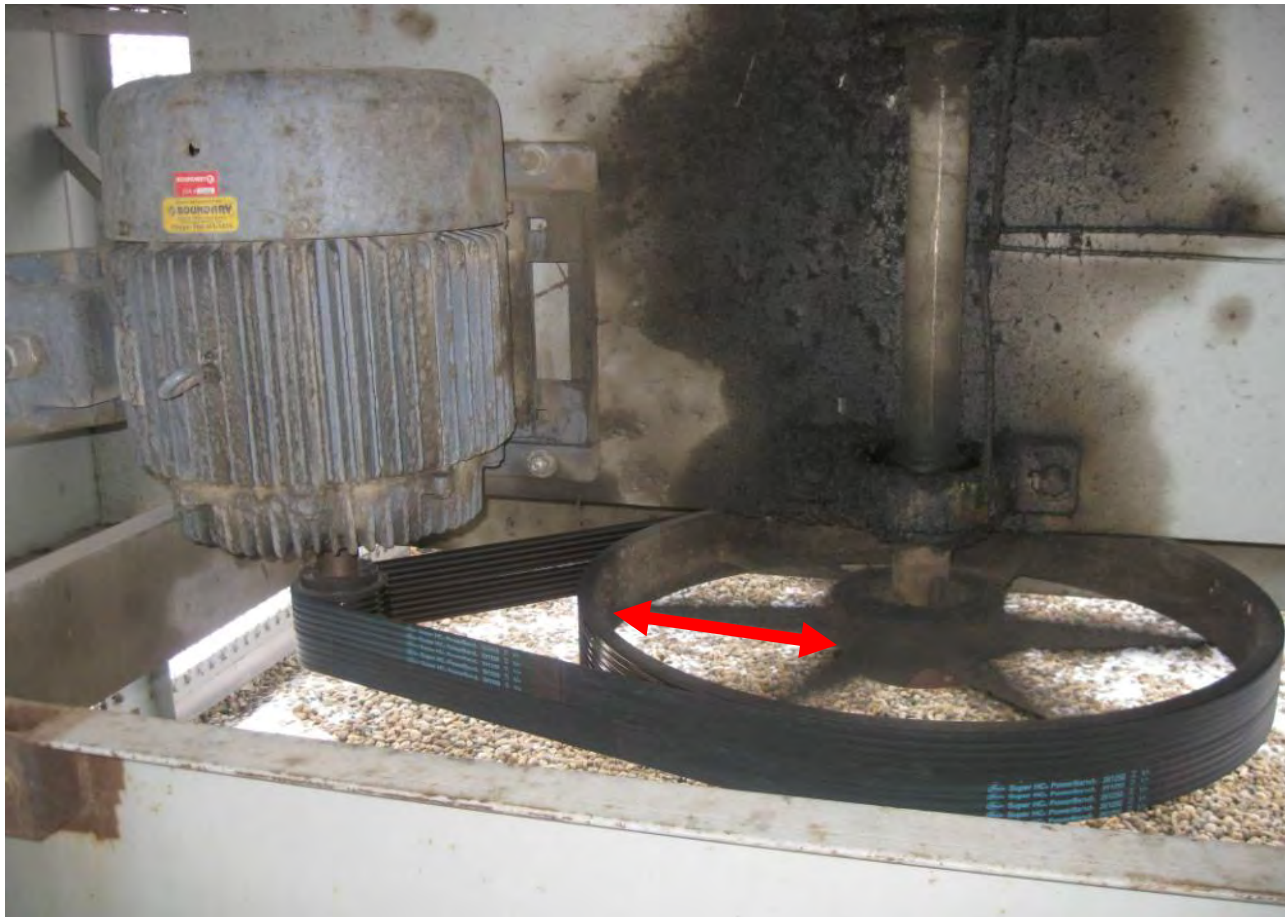
V-belts slip, look at the belt wrap and worn pulleys.
This lowers the speed of the Fan, which will lower
airflow and production.

Also this small pulley has 30% more load over the next
slide with the Gates Poly chain

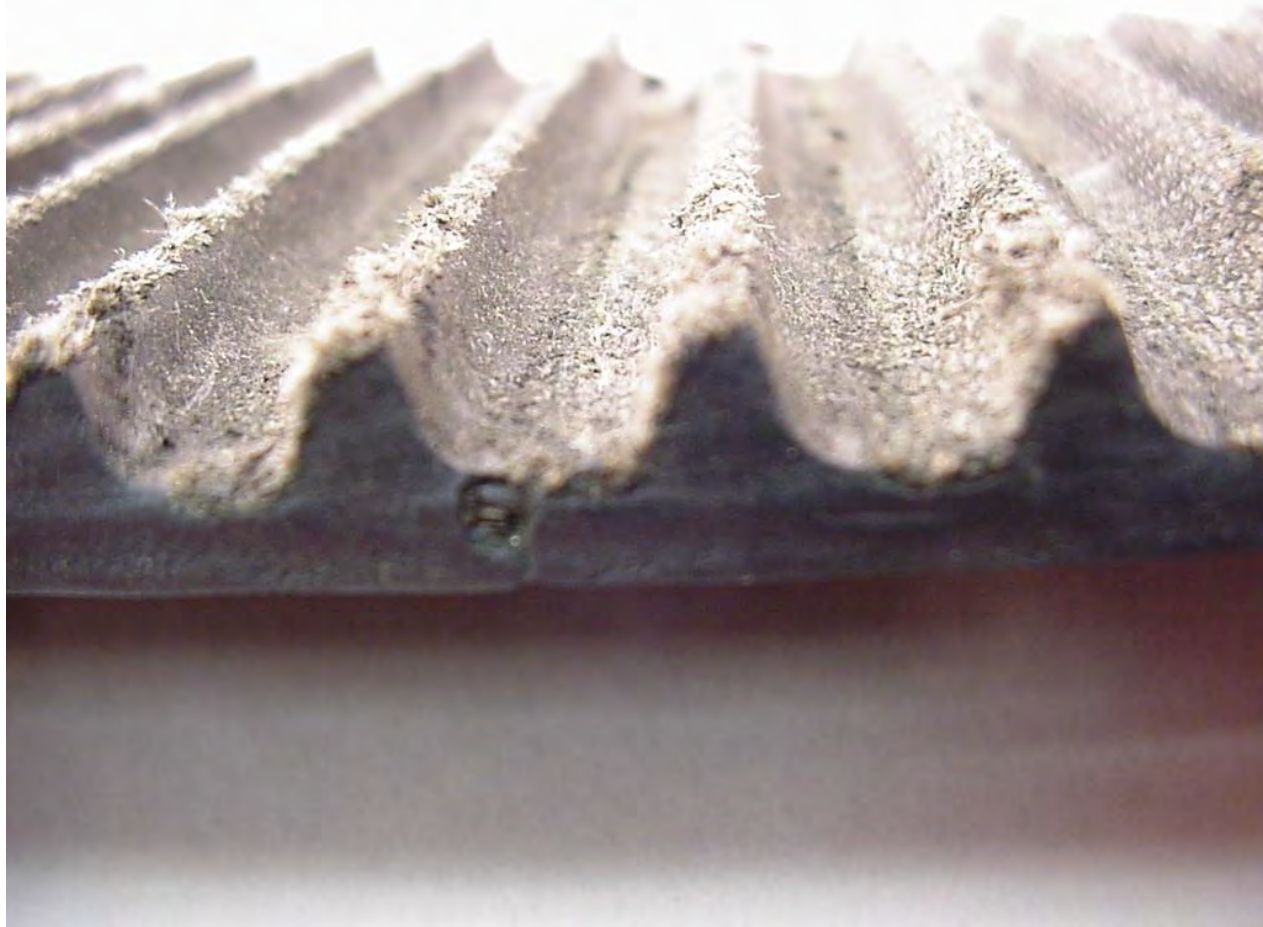
Under tensioning gives you...“Sharks fins”

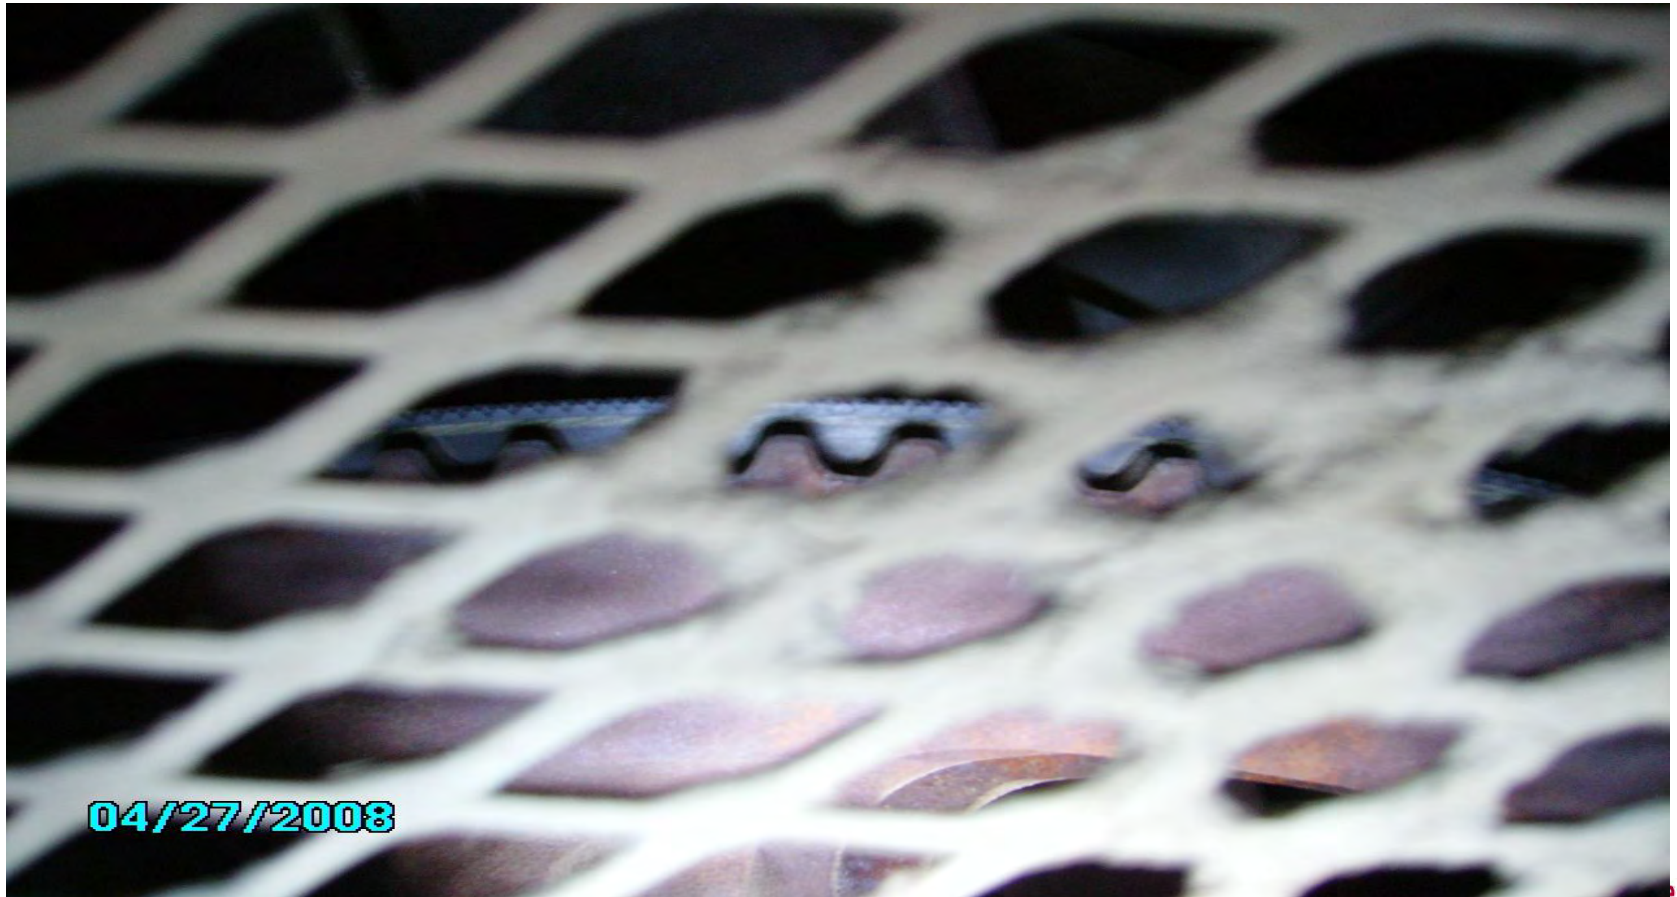
Not too bad but could be better...

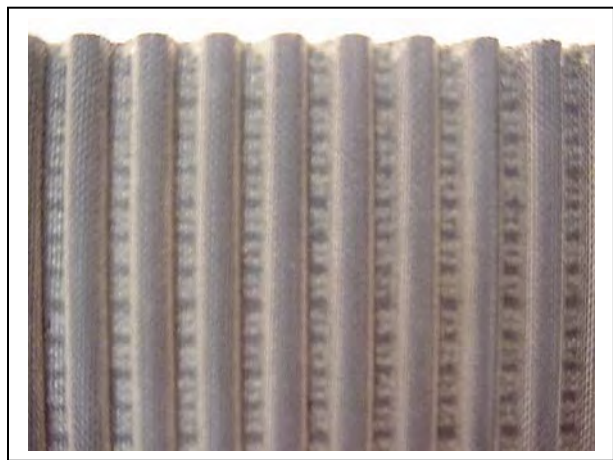
Figure 2 - Frayed Jacket

Synchronous belt teeth can also fail, but is considered to be a non-ideal type of belt failure. After a long period of service, belt teeth may appear to be worn, although they should retain their original size and form. Protruding fibers from the jacket may give belt teeth a fuzzy appearance, as illustrated in Figure 2.

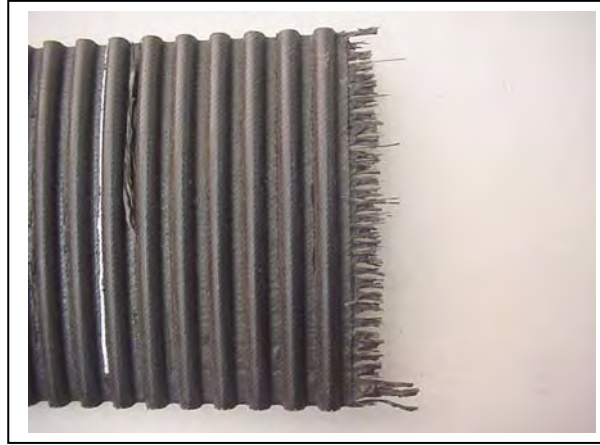
Figure 3 - Crimp Failure

A “Crimp” type belt failure often resembles a straight tensile failure as illustrated in Figure 3. A straight type of break like this may occur when belt tensile cords are bent around an excessively small diameter. A sharp bend may result in large compressive forces within the tensile members causing individual fibers to buckle or crimp, reducing the overall ultimate tensile strength of the belt. Belt crimping damage is most commonly associated with belt mishandling, inadequate belt installation tension, sub-minimal sprocket diameters, and/or entry of foreign objects within the belt drive.

Belt crimping due to mishandling can result from improper storage practices, improper packaging, and belt handling prior to and during installation. (*For more information on proper belt handling, see PA Note Volume 49, No. 5*).

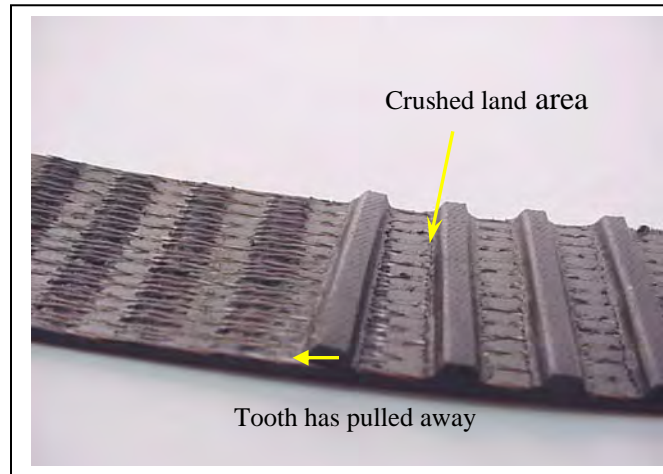
Figure 6 - Sprocket Run-Out

Belts operating on sprockets with radial run out are subjected to a cyclic rise and fall in belt tension as the sprockets rotate. The greater the run out, the higher the peak belt tension grows. Belts subjected to significant cyclic peak tensions exhibit land areas with a crushed appearance. Crushed land areas and tooth shear are both visible in Figure 6. A crushed land area condition may appear similar to belts operating on moderate size sprockets under excessively high tensions. Belts subjected to extreme cyclic belt tension variations often fail from either tooth shear or tensile break.

Excessive sprocket run out is most often observed when sprockets are mounted improperly on bushings, or when minimum plain bore sprockets are improperly re-bored and mounted. Sprocket re-boring instructions and shaft / bore fit recommendations are published in the Poly Chain GT2 Drive Design Manual (17595) and the PowerGrip GT2 Drive Design Manual (17195).

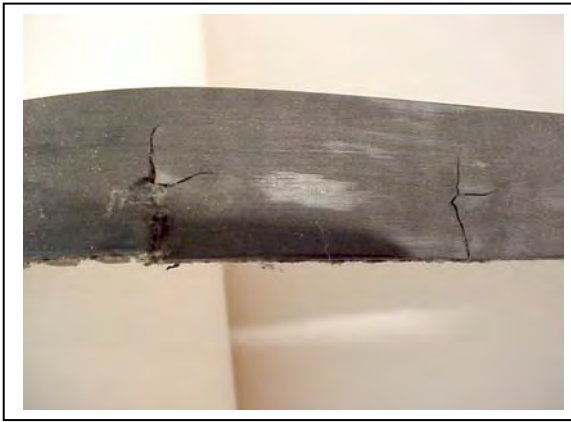
Figure 4 – Tensile Cord Failure From Debris

The introduction of foreign objects between a belt and sprocket often damages both belt teeth and tensile cords. Tensile cords often fracture internally (Figure 4) or fail later due to crimping (bending too tightly) (Figure 5). Once a portion of the tensile cords have fractured, the remaining tensile strength of the belt has been reduced considerably. This often results in a dramatic reduction in belt life. If belt damage from debris is noticeable, the belt should be replaced and the sprockets checked for damage. Damaged sprockets should also be replaced.
