# GATES POLY CHAIN CARBON and AIR COOLED HEAT EXCHANGERS

# **PRODUCT APPLICATION NOTES**

## **Primary Causes of Synchronous Belt Failures (Part 1 of 4)**

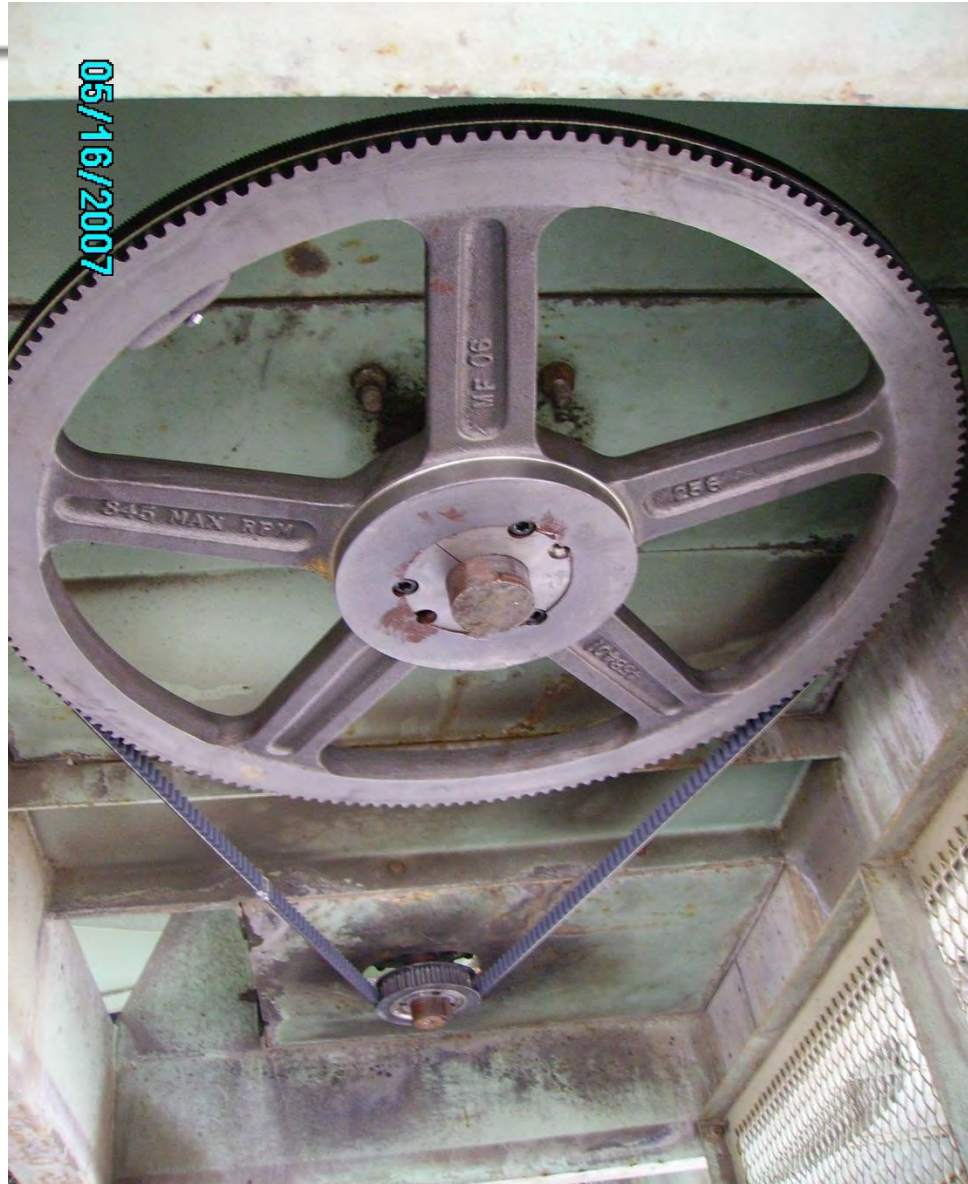
V-belts slip, look at the belt wrap and worn pulleys.  
This lowers the speed of the Fan, which will lower  
airflow and production.

Also this small pulley has 30% more load over the next  
slide with the Gates Poly chain

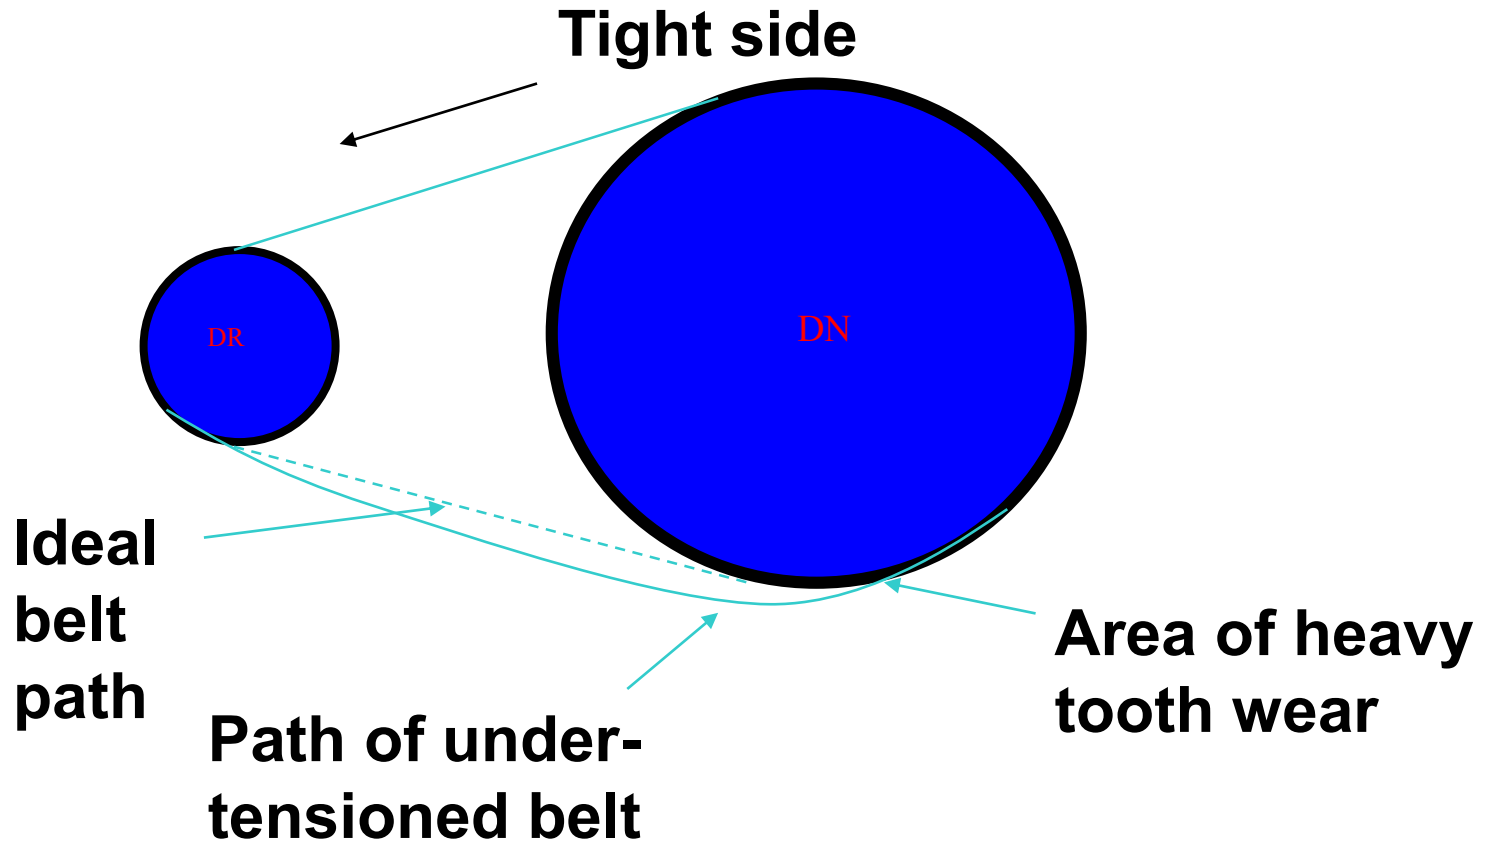
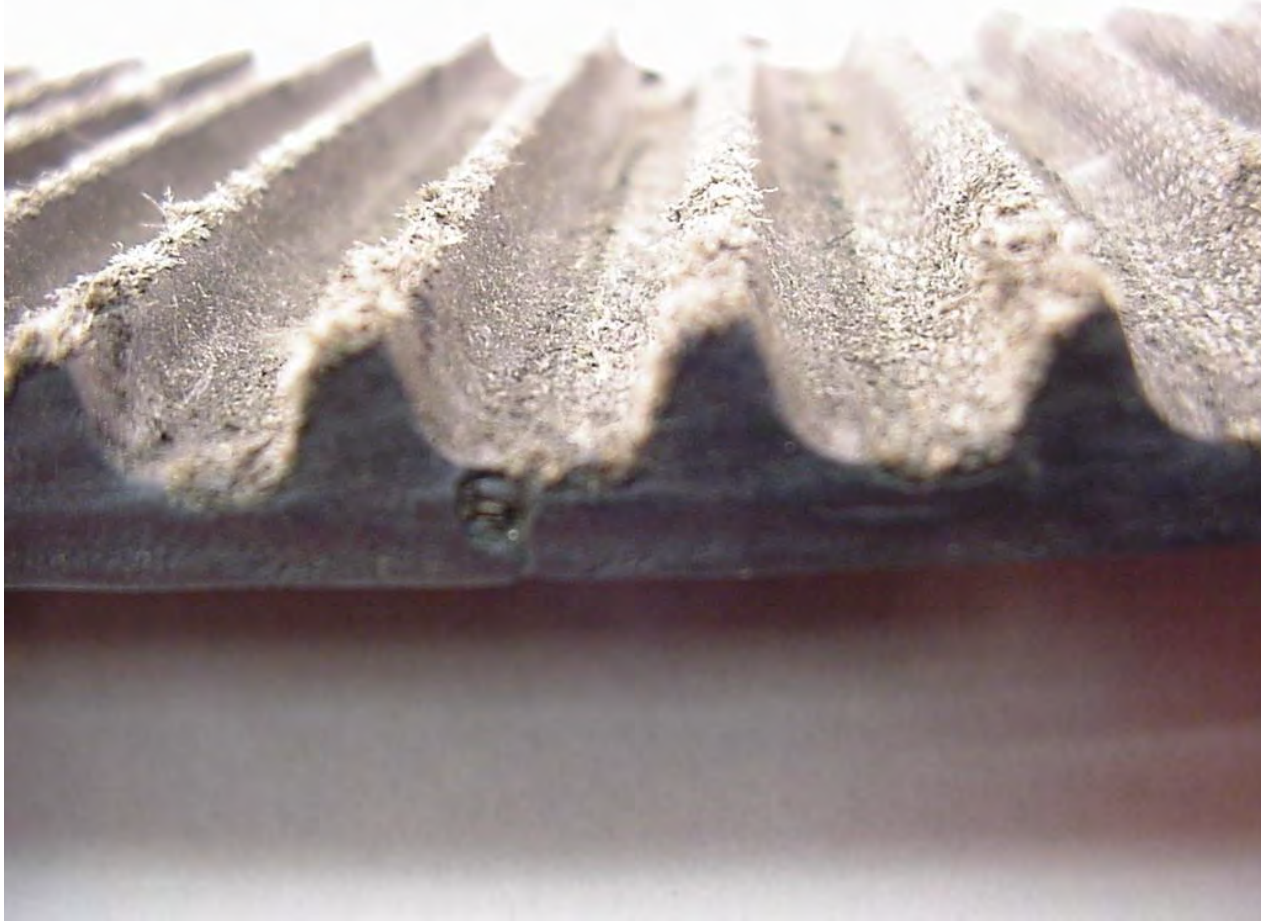
# Under-Tensioned Belt

**Under tensioning gives  
you...“Sharks fins”**

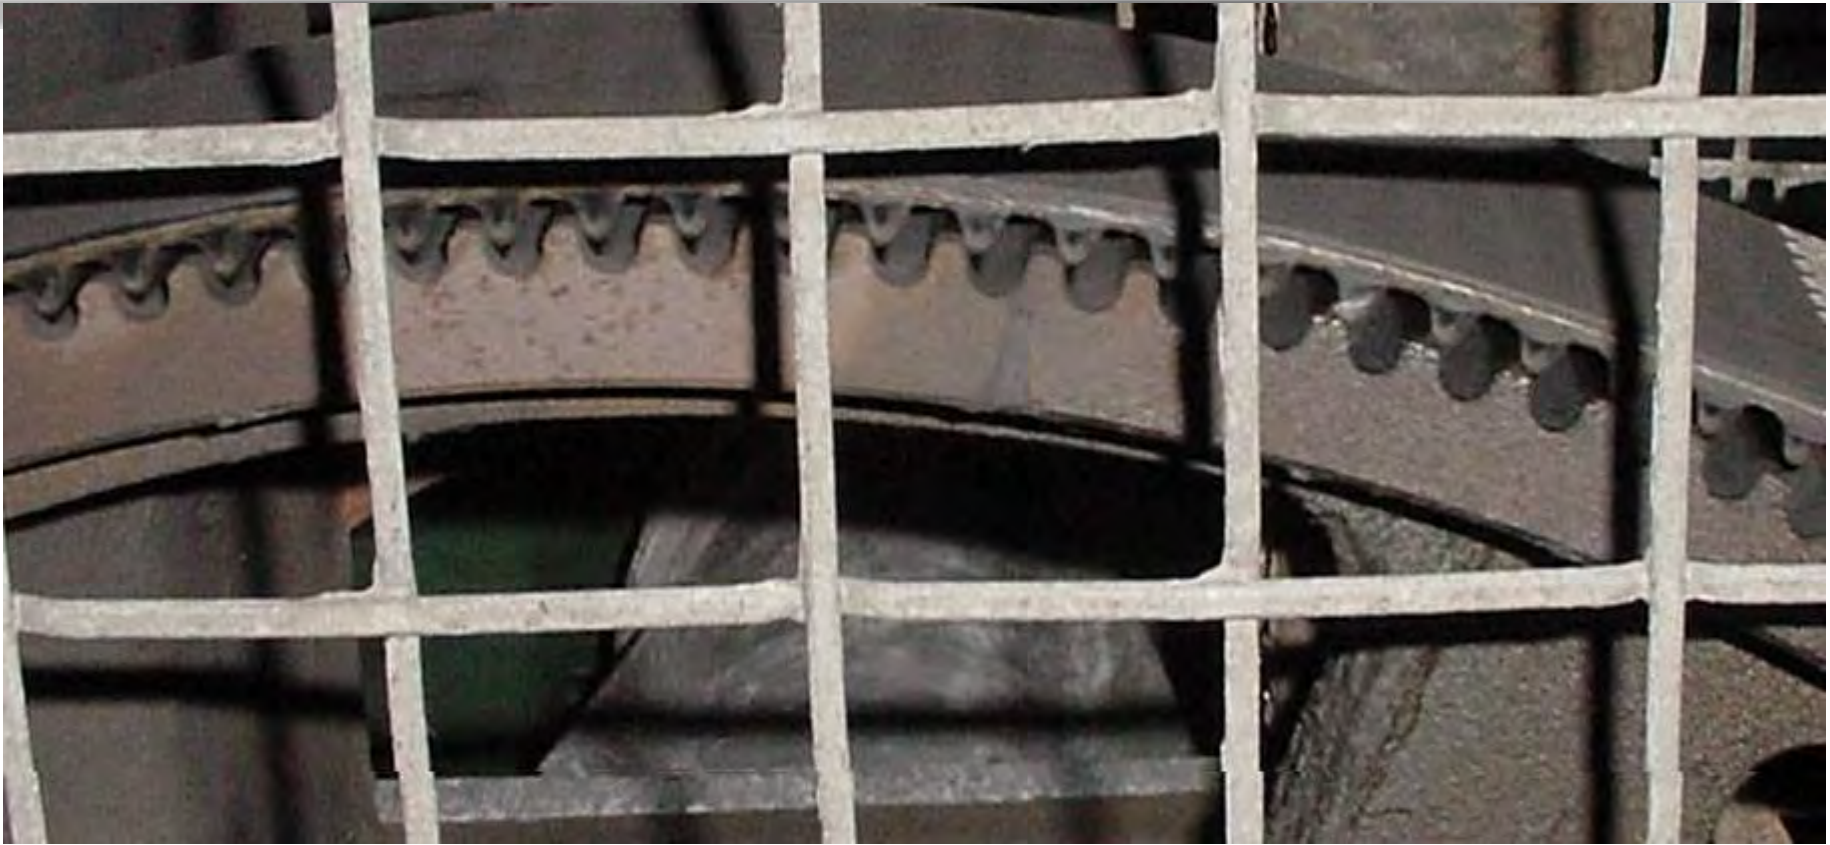
# **Incorrect Meshing on Driven Pulley**

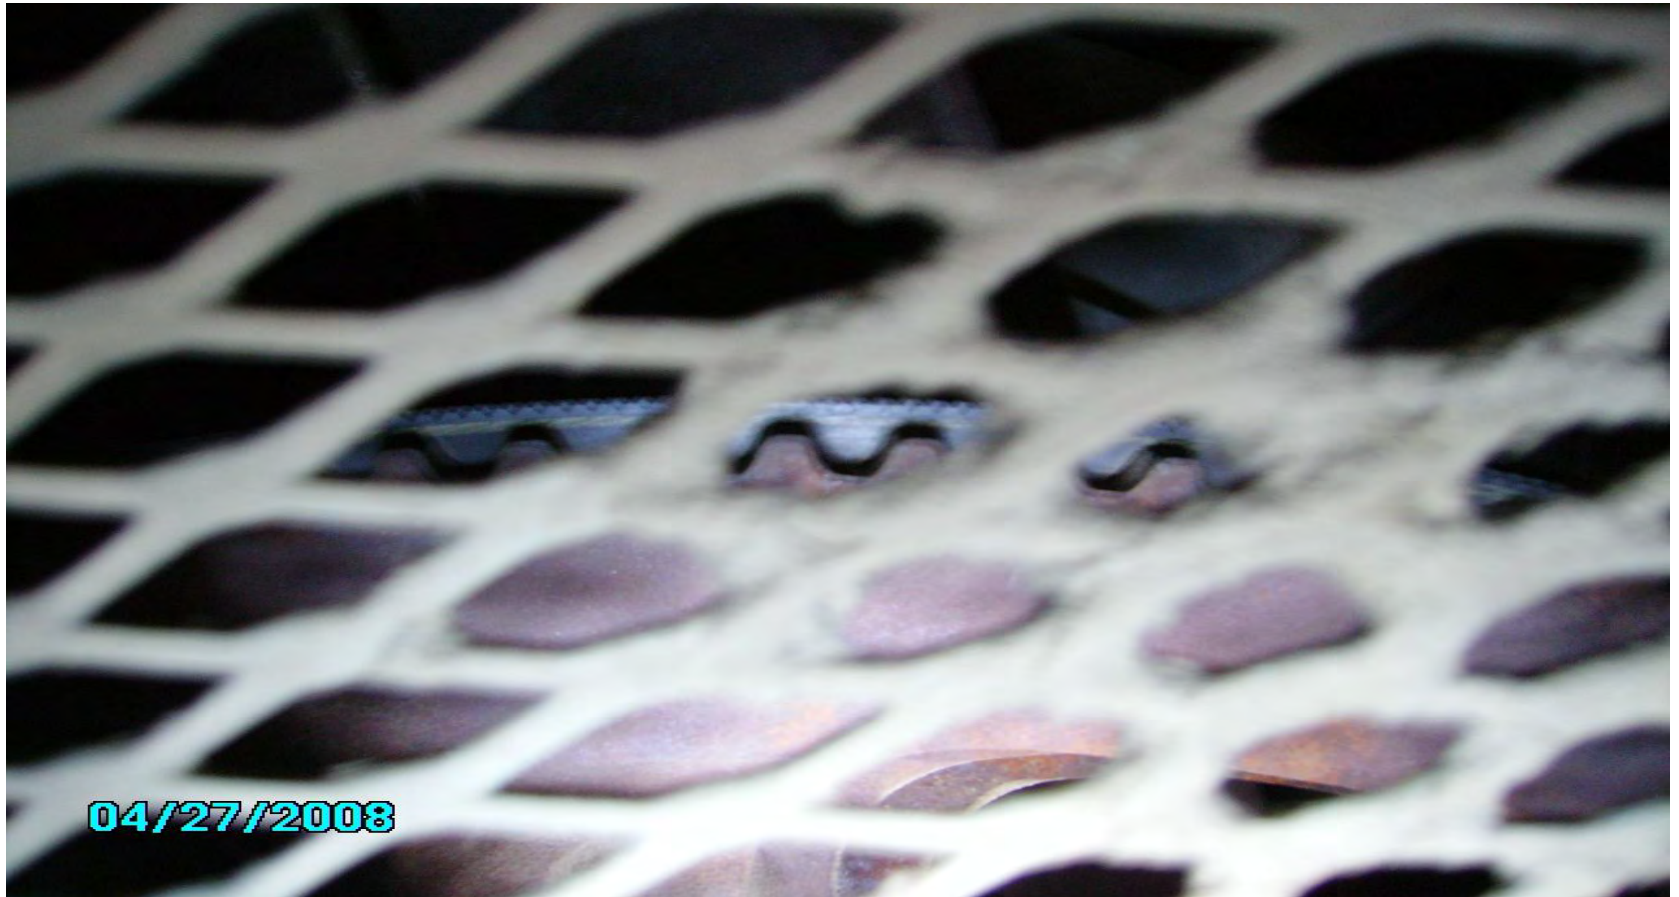
**Loaded drive running - photographed with Strobe Light.**

**Not too bad but could be better...**

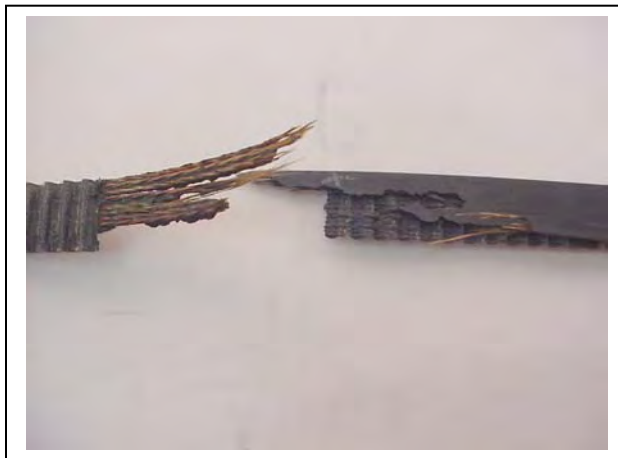
**Figure 1 - Normal Tensile Failure**

A failure that occurs when a belt reaches its ultimate tensile cord fatigue life, after running for a period of 2 to 3 years, is considered to be normal. Belt tensile failure due to cord fatigue after a long running period is considered to be ideal. Figure 1 illustrates a jagged 45 deg. belt fracture that is typical of tensile cord at the end of its normal fatigue life.

No corrective action is needed for belts performing for a normal 2 to 3 year time period. Belt life can vary significantly from application to application due to numerous factors. Factors affecting belt life include the transmitted power level, the environment, belt installation tension, shaft/sprocket alignment, sprocket condition, and even how the belt was handled prior to and during installation.

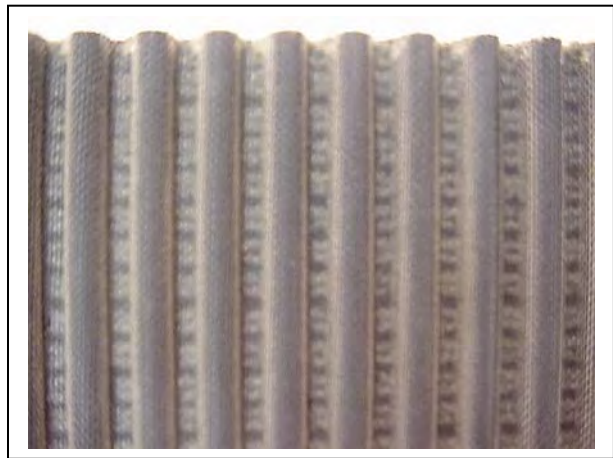
**Figure 2 - Frayed Jacket**

Synchronous belt teeth can also fail, but is considered to be a non-ideal type of belt failure. After a long period of service, belt teeth may appear to be worn, although they should retain their original size and form. Protruding fibers from the jacket may give belt teeth a fuzzy appearance, as illustrated in Figure 2.

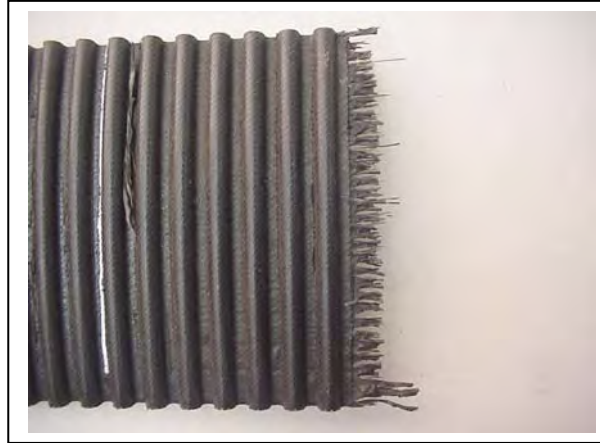
**Figure 3 - Crimp Failure**

A “Crimp” type belt failure often resembles a straight tensile failure as illustrated in Figure 3. A straight type of break like this may occur when belt tensile cords are bent around an excessively small diameter. A sharp bend may result in large compressive forces within the tensile members causing individual fibers to buckle or crimp, reducing the overall ultimate tensile strength of the belt. Belt crimping damage is most commonly associated with belt mishandling, inadequate belt installation tension, sub-minimal sprocket diameters, and/or entry of foreign objects within the belt drive.

Belt crimping due to mishandling can result from improper storage practices, improper packaging, and belt handling prior to and during installation. (*For more information on proper belt handling, see PA Note Volume 49, No. 5*).

Belts operating in an under tensioned condition may allow belt teeth to ride out of the sprockets until an acceptable belt tension level is achieved. This phenomenon is called “self-tensioning”. Self-tensioning can be most clearly observed at the point of lowest dynamic belt span tension, or where the belt teeth are entering the driven sprocket grooves. When a belt is self tensioning, the belt teeth ride up out of the sprocket grooves until increased span tension from the approaching tight side tension forces the belt teeth back down into the sprocket grooves. The point at which the belt teeth are forced back down into the sprocket grooves often results in a sharp, momentary point of bending that can result in belt tensile cord damage. This point of tensile cord damage is referred to as a crimp. If the tight side tension does not force the belt teeth back down into the sprockets grooves, the belt will ratchet. Belt ratcheting can also result in tensile cord crimp and belt tooth damage.

Subjecting belts to sub-minimal bend diameters can also result in belt tensile cord damage, or crimping. This can be caused by sprockets or flat backside idlers in sub-minimal sizes, or even hand bending a belt too sharply.

Foreign objects located between the belt and sprocket can also result in belt crimping. They can lift the belt away from the sprocket at a sharp angle, creating a point of tensile cord crimp. Tools, such as screw drivers or bars, used to force belts on to sprockets can also cause belt cord crimp damage. Belts subjected to foreign objects or improper use of tools during installation may not fail immediately after being damaged; however overall belt life will be reduced.

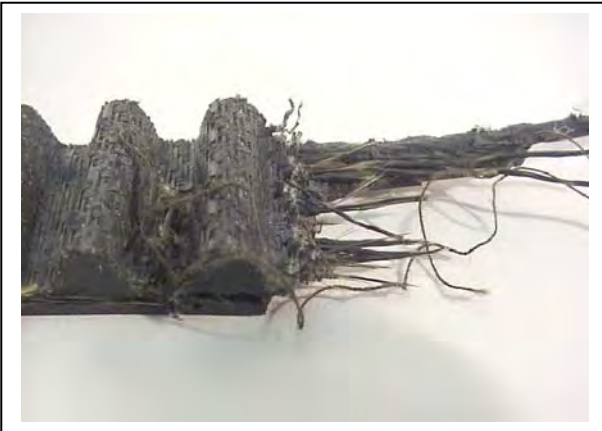
**Figure 4 - Shock load Failure**

Severe shock loads can result in belt tensile breaks with a ragged and uneven appearance as illustrated in Figure 4. The particular belt teeth engaged in the sprocket at the instant of the shock load may also develop root cracks and/or exhibit tooth shear. If the shock load occurred only once, or was cyclical and repetitious at one specific location around the belt, the remaining belt teeth may appear normal. Figure 5 illustrates how root cracks caused by shock loading can propagate through the teeth. Cracks forming at the tooth roots sometimes move towards the tooth tips. Teeth containing multiple cracks may then shear, leaving only a portion of the tooth behind.

The shock loads generated by the driven equipment may be an inherent part of system operation, or may result from an occasional harsh condition such as jamming. If the drive shock loads cannot be eliminated, the belt tensile strength may need to be increased or the synchronous belt drive replaced with a more forgiving V-belt drive system capable of intermittent slip.

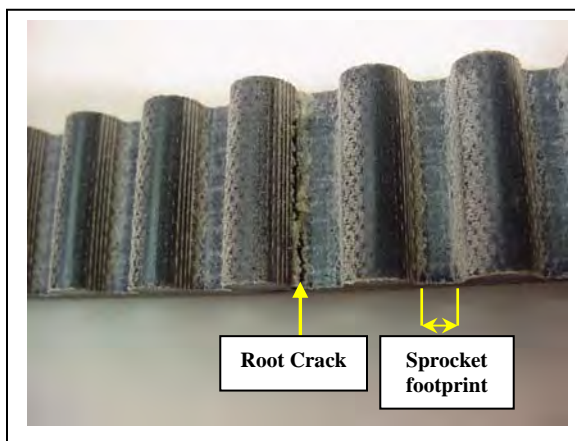
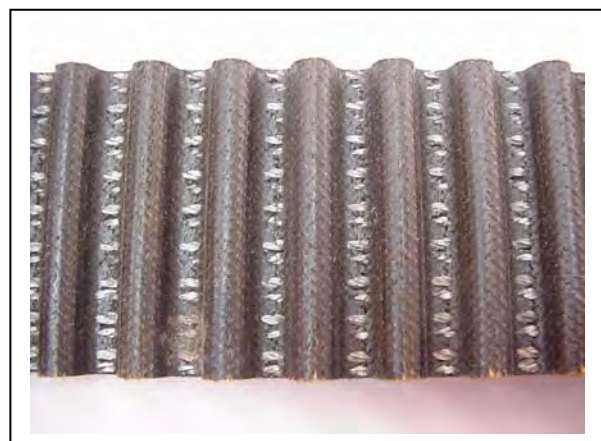
Applying excessive installation tension to a synchronous belt may result in belt tooth shear or even a tensile break. Many belts that have been excessively tensioned show visible signs that sprockets have worn the belt land areas. Figure 1 illustrates a belt with crushed land areas and a crack that formed at the root of the belt tooth. A root crack will often propagate down to the tensile member and travel to the next root crack. Individual belt teeth will then separate from the body of the belt and often fall off. Figure 2 illustrates a belt that had been over tensioned on large sprockets. High belt land pressures caused excessive belt land area wear, ultimately revealing individual tensile cords. In order to prevent belt wear problems like these, proper belt installation tension levels must be determined and set accurately.

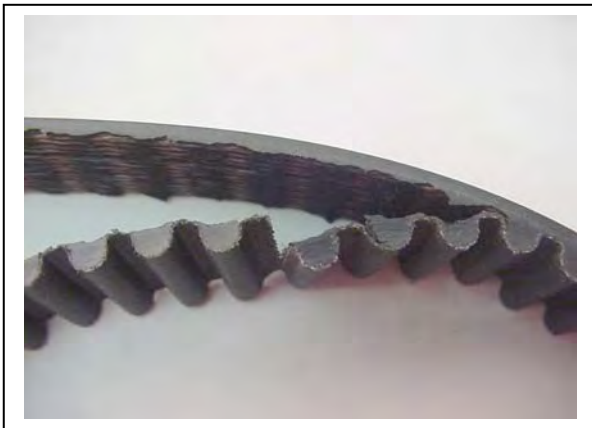
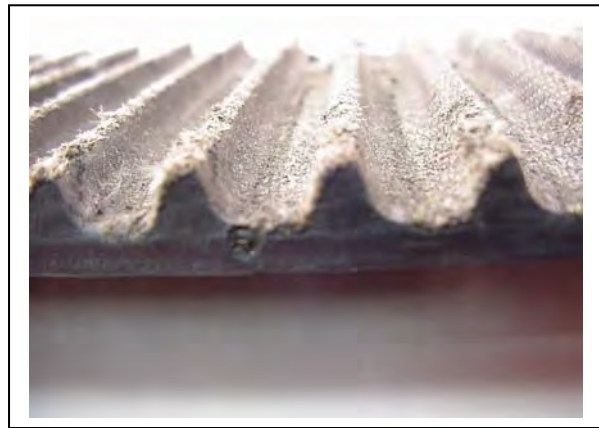
Applying insufficient installation tension to belts operating on moderately to heavily loaded drive systems may also result in premature failures. A common belt failure mode resulting from insufficient belt installation tension is referred to as tooth rotation. Belt tooth rotation can occur as belt teeth climb out of their respective sprocket grooves (self tensioning) and drive loads are

no longer applied at their roots. Drive loads applied further down the belt tooth flanks cause the belt teeth to bend (like a diving board), and “rotate”. Belt tooth rotation can result in rubber tearing at the base of the belt teeth along the tensile member. As rubber tearing propagates, belt teeth often begin to separate from the belt body in strips, as illustrated in Figure 3. Failures due to excessive tooth rotation may resemble failures caused by insufficient rubber adhesion to the tensile cords. Failures from insufficient rubber adhesion, however, leave the exposed tensile members clean where the belt teeth were once located unlike tooth rotation failures.

As belt teeth climb out of their respective sprocket grooves to self tension, belt ratcheting or tooth jumping may occur before rubber tearing and belt tooth separation occurs. Belt tensile cord damage resulting from ratcheting can cause premature belt tensile failures. These tensile failures may resemble crimp type breaks (straight and clean) as well as shock load type breaks (jagged and angled). If belt ratcheting does not occur and belts continue to operate while self tensioning, excessive belt tooth wear often occurs. This tooth wear is referred to as “hook wear” and results from improper belt tooth meshing with the sprockets, Figure 4. Hook wear type belt failures result from insufficient belt installation tension, and from weak drive structures that allow center distance flexing while the drive system is under load.

Increasing belt installation tension levels generally prevents premature belt failures due to tooth rotation and hook wear. If increasing the belt installation tension level does not prevent this type of failure, the drive structure may not be rigid enough to prevent deflection. Added structural support may be necessary to improve belt performance. If it is not practical to increase belt installation tension levels, increasing the sprocket diameters will allow higher drive loads to be transmitted with less belt tension.

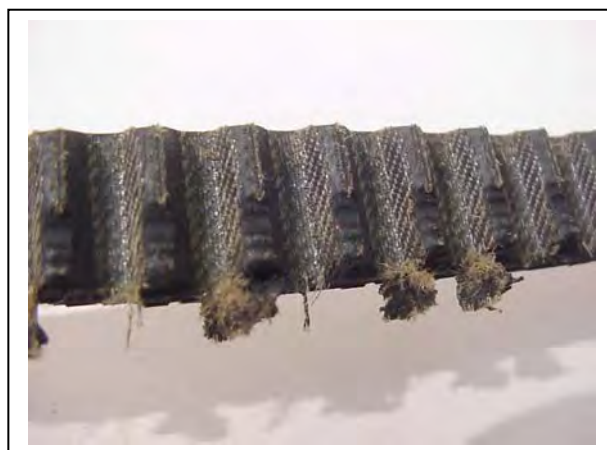
Figure 1 – Angular Misalignment

Belts operating on drives with angular shaft misalignment or tapered sprockets often exhibit an uneven wear pattern across the belt tooth flanks and uneven compaction in the land areas (in-between belt teeth) due to the uneven application of load to the belt. Belt failures often occur from tooth root cracks or tears initiating on the side of the belt that is carrying the highest tension and propagating across the belt width, ultimately resulting in tooth shear. One edge of the belt may also show significant wear due to high tracking force, and may even roll up or attempt to climb the sprocket flange(s). Figure 1 shows extreme belt edge wear from a high tracking force.

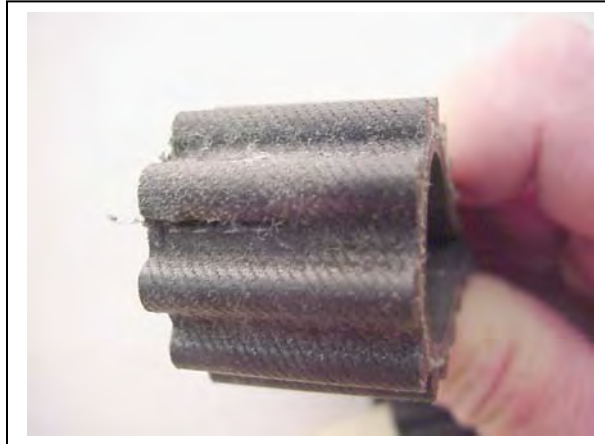
**Figure 2 – Parallel Misalignment**

Belts operating on flanged sprockets with parallel misalignment (offset sprockets) may exhibit excessive belt edge wear on both edges if the belt is pinched between opposite flanges. Belt failures may then occur by tooth root cracks or tears initiating from both edges of the belt. These tears may eventually extend across the entire width of the belt, resulting in tooth shear.

Belts operating on a combination of both flanged and non-flanged sprockets with parallel misalignment may walk or track partially off of the non-flanged sprocket(s). The portion of the

belt remaining engaged with the non-flanged sprocket(s) will carry the full operating load and may develop a concentrated area of wear after running this way for a period of time. Figure 2 shows concentrated wear across the majority of the belt tooth face with a portion relatively unworn. A root crack has also developed below the worn area. This may ultimately result in premature belt failure due to either tensile or tooth fatigue.

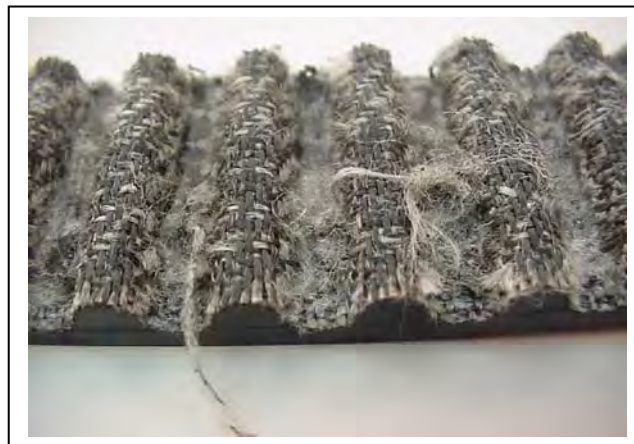
**Figure 3 - Belt from Worn Sprocket**

Belts operating on sprockets that are out of dimensional specification often show a high degree of tooth flank wear with the jacket flank exhibiting a fuzzy or flaking appearance, as shown in Figure 3.

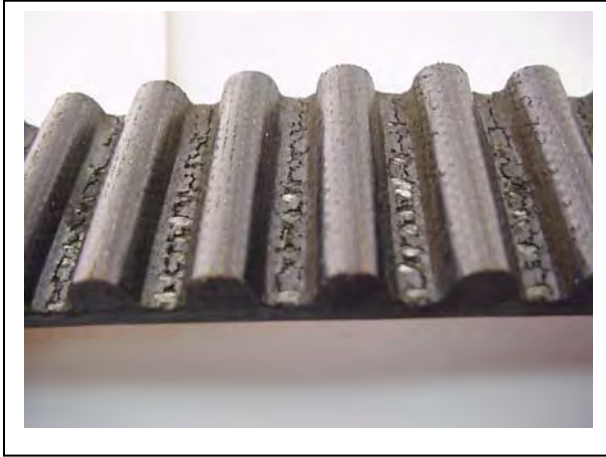
**Figure 4 - Sub-minimal Sprocket Belt Failure**

Curvilinear (HTD and GT) belts operating on sub-minimal sprocket diameters usually fail by land disintegration, illustrated in Figure 4, and tensile breaks. Trapezoidal (XL, L, H) belts will usually fail by tooth root cracks and tooth shear; however tensile breaks are not uncommon.

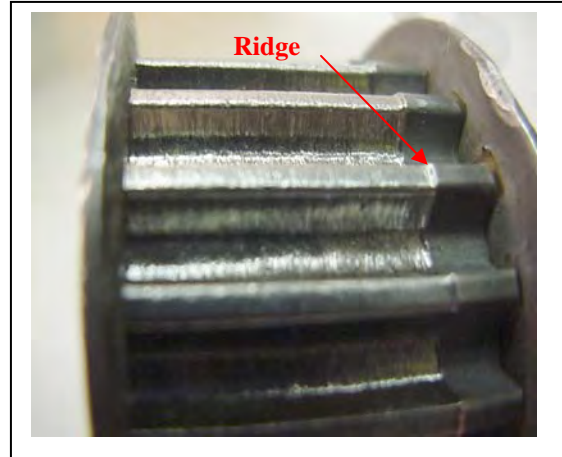
**Figure 5 - Worn Sprocket**

A higher rate of sprocket wear may occur from belts that have been installed with excessive installation tension. Belts that have been in operation for a long time have sometimes had the tooth facing or jacket completely worn away. Belts in this condition indicate that significant sprocket wear may have also occurred. Belts worn to this point also sometimes allow belt tensile members to contact the sprockets resulting in a grooved wear pattern around the outside circumference.

A good indication of sprocket wear is when a ridge along the tip of sprocket teeth becomes visible, as illustrated in Figure 5. It is best to use a screwdriver to feel for the ridge in order to prevent finger cuts. **Caution - Severely worn surfaces on sprocket faces may become very sharp.** When a ridge on the sprocket face is detected, the sprockets should be replaced.

The most rapidly and severely worn sprockets are most commonly found in abrasive atmospheres. Severely worn sprockets often exhibit groove wear as well as a reduction in the outside finish diameter. A typical belt failure on worn sprockets exhibits polished land wear and may have teeth worn to the point of serious dimensional distortion (hook wear). Sprockets plated with a hard chrome finish can be used to extend the sprocket life in abrasive atmospheres.

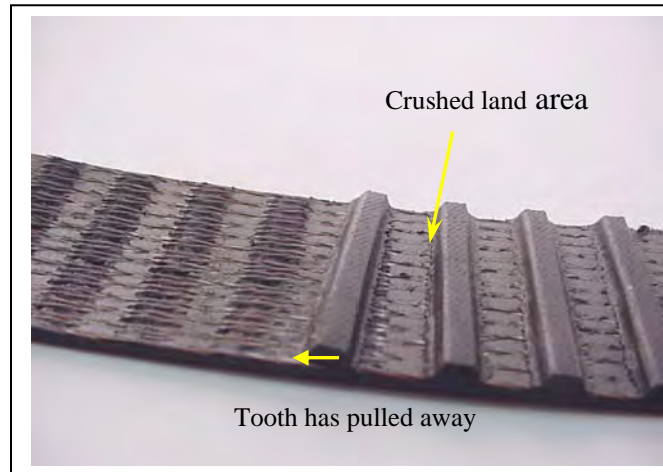
**Figure 6 - Sprocket Run-Out**

Belts operating on sprockets with radial run out are subjected to a cyclic rise and fall in belt tension as the sprockets rotate. The greater the run out, the higher the peak belt tension grows. Belts subjected to significant cyclic peak tensions exhibit land areas with a crushed appearance. Crushed land areas and tooth shear are both visible in Figure 6. A crushed land area condition may appear similar to belts operating on moderate size sprockets under excessively high tensions. Belts subjected to extreme cyclic belt tension variations often fail from either tooth shear or tensile break.

Excessive sprocket run out is most often observed when sprockets are mounted improperly on bushings, or when minimum plain bore sprockets are improperly re-bored and mounted. Sprocket re-boring instructions and shaft / bore fit recommendations are published in the Poly Chain GT2 Drive Design Manual (17595) and the PowerGrip GT2 Drive Design Manual (17195).

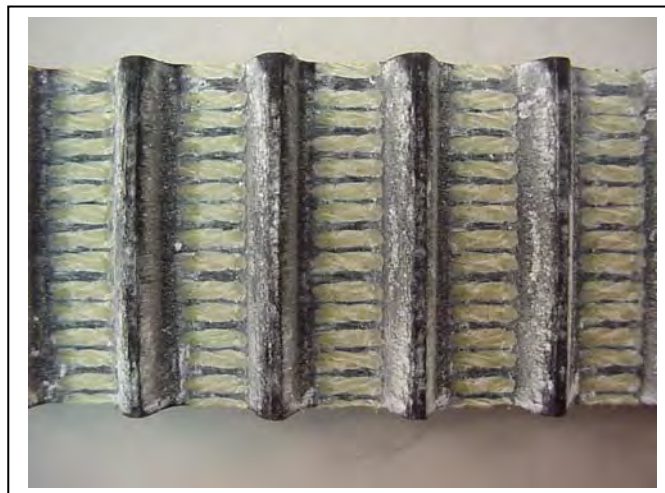
Figure 1- Belt Wear From Abrasive Atmosphere

Belts operating in abrasive atmospheres on applications like foundry shakers, taconite processing equipment, and phosphate mining conveyors, often exhibit a high degree of belt land and tooth flank wear. Worn areas frequently have a polished appearance. Figure 1 illustrates a severely worn Poly Chain GT2 belt that ran in a highly abrasive environment. Sprocket wear is generally rapid in abrasive environments; therefore sprockets should be replaced along with belts. To extend the life of belts and sprockets, a sealed guard that is pressurized with clean air can be installed to help keep out abrasive dust and contaminants.

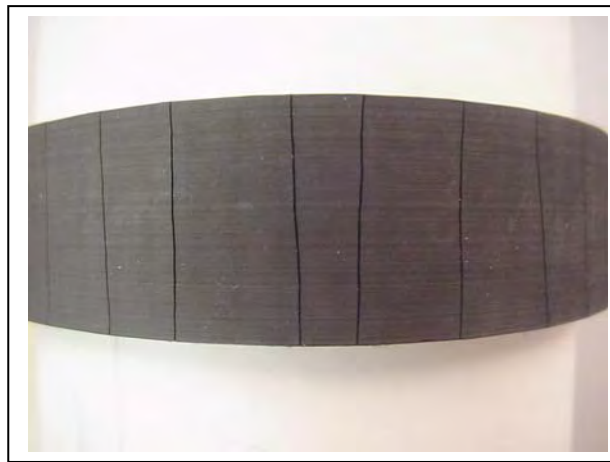
**Figure 2 - Rubber Cracking Due To Excessive Heat**

When rubber belts operate at elevated temperatures (greater than 185°F) for prolonged periods of time, the rubber compound gradually hardens resulting in back cracking due to bending. These cracks typically remain parallel to the belt teeth and usually occur over land areas (in between belt teeth), as illustrated in Figure 2. Belts generally fail due to tooth shear which often leads to tensile cord fracture.

High temperature rubber belt constructions are available for belt drives that must operate in high temperature environments. These special belt constructions help to improve belt service. To determine if a special high temperature belt construction will improve the belt performance in specific applications, contact a Gates Representative.

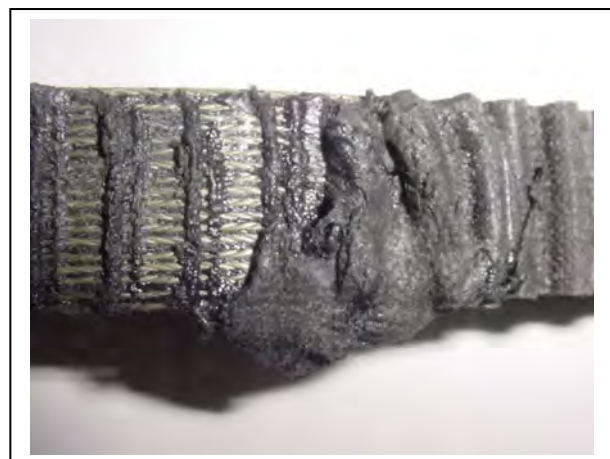
**Figure 3 - Poly Chain GT2 Failure Due To Excessive Heat**

The body material used in urethane belts such as Poly Chain GT2 is thermoplastic (has a melting point). When subjected to environmental temperatures in excess of 185°F, the teeth may begin to soften and deform. In addition, the tensile cord to urethane adhesion loses its integrity. Figure 3 illustrates a Poly Chain GT2 belt that was exposed to a high environmental temperature.

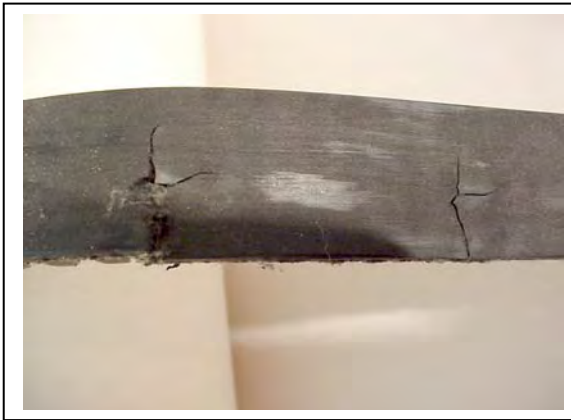
**Figure 4 – Tensile Cord Failure From Debris**

The introduction of foreign objects between a belt and sprocket often damages both belt teeth and tensile cords. Tensile cords often fracture internally (Figure 4) or fail later due to crimping (bending too tightly) (Figure 5). Once a portion of the tensile cords have fractured, the remaining tensile strength of the belt has been reduced considerably. This often results in a dramatic reduction in belt life. If belt damage from debris is noticeable, the belt should be replaced and the sprockets checked for damage. Damaged sprockets should also be replaced.
