GATES POLY CHAIN CARBON and AIR COOLED HEAT EXCHANGERS

Why Poly Chain Synchronous?

Primary Causes of Synchronous Belt Failures (Part 1 of 4)

Primary Causes of Synchronous Belt Failures (Part 2 of 4)

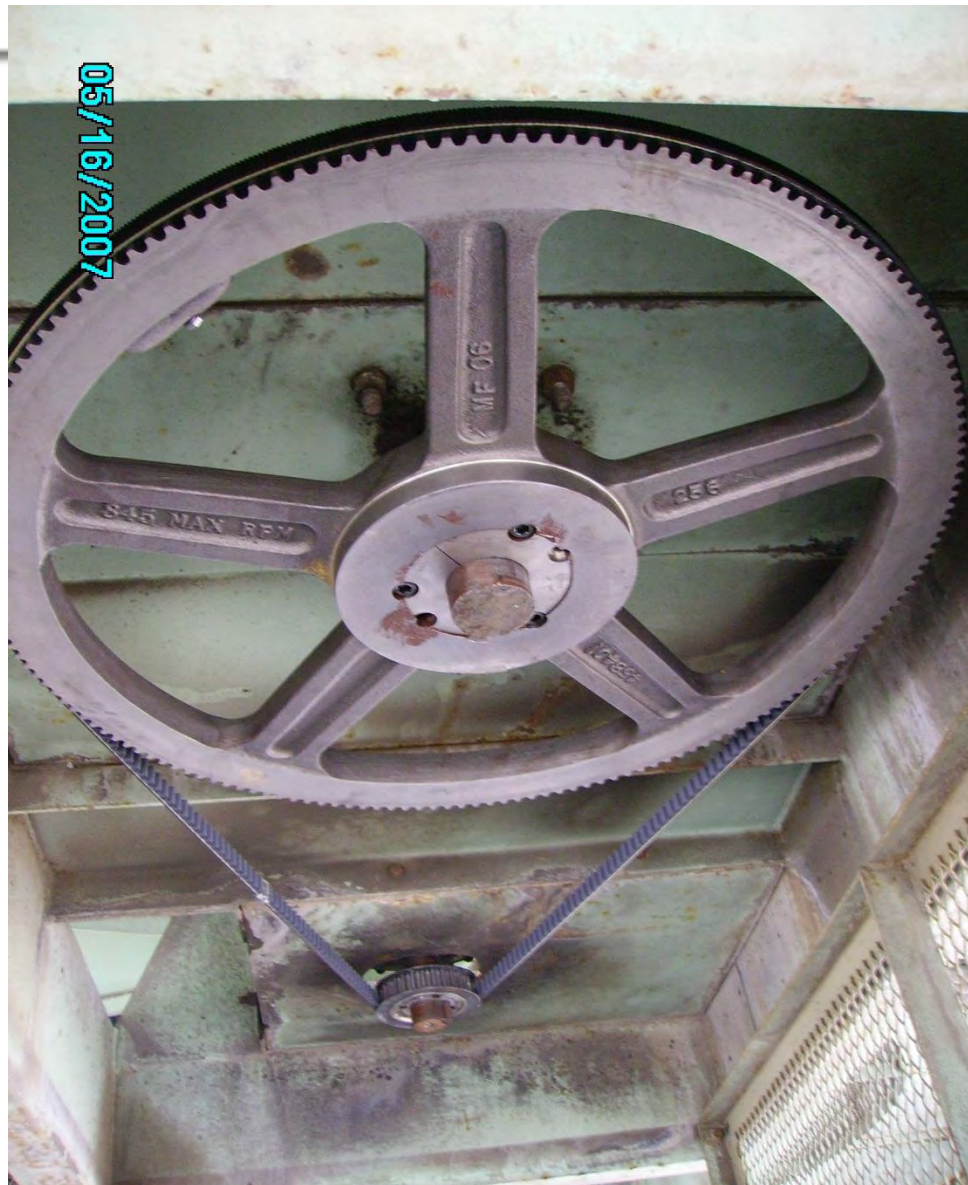
V-belts slip, look at the belt wrap and worn pulleys.
This lowers the speed of the Fan, which will lower
airflow and production.

Also this small pulley has 30% more load over the next
slide with the Gates Poly chain

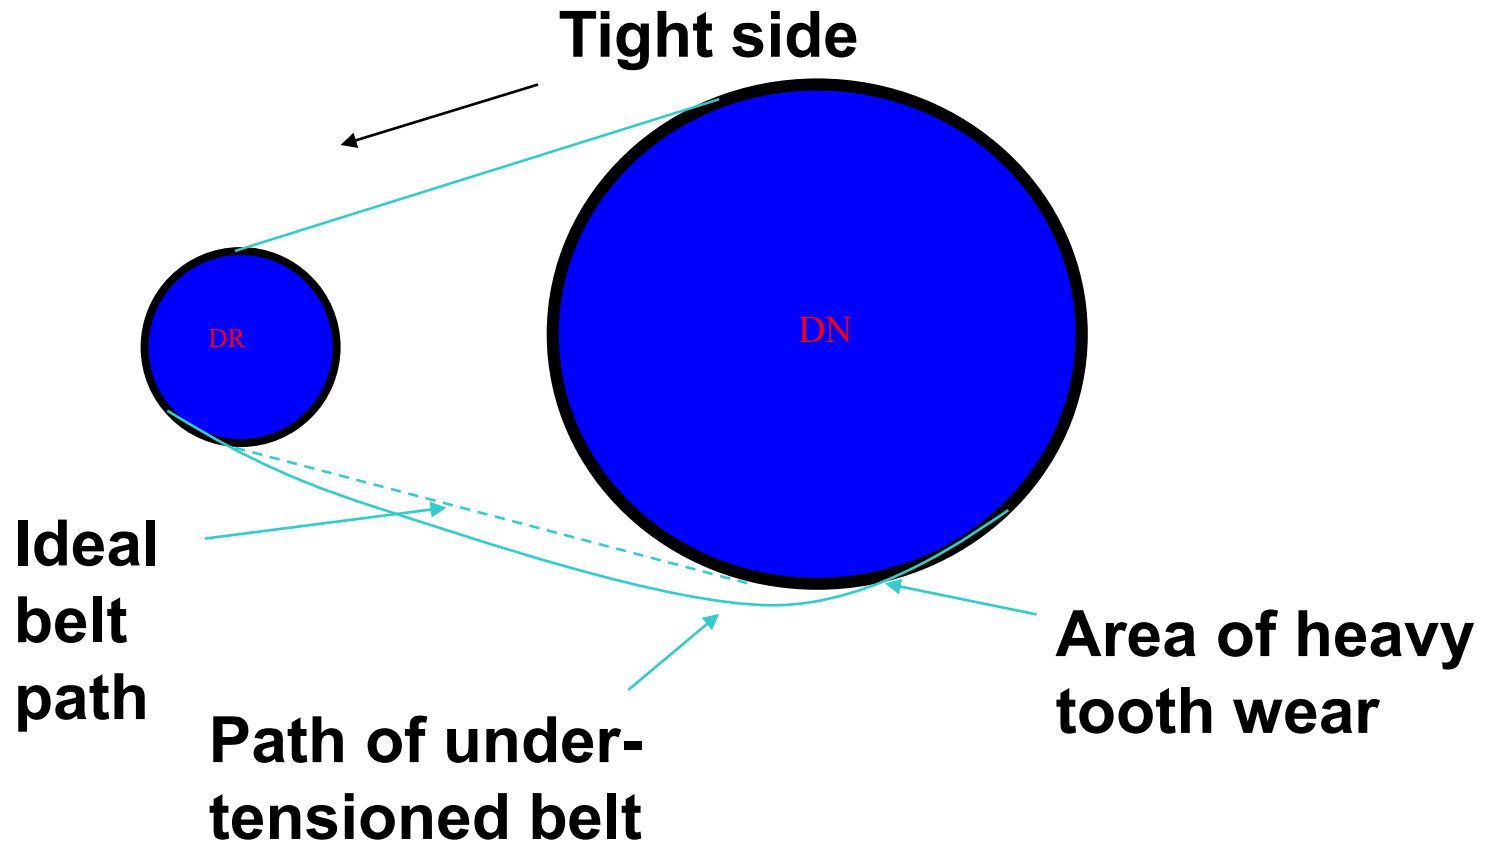
Under-Tensioned Belt

**Under tensioning gives
you...“Sharks fins”**

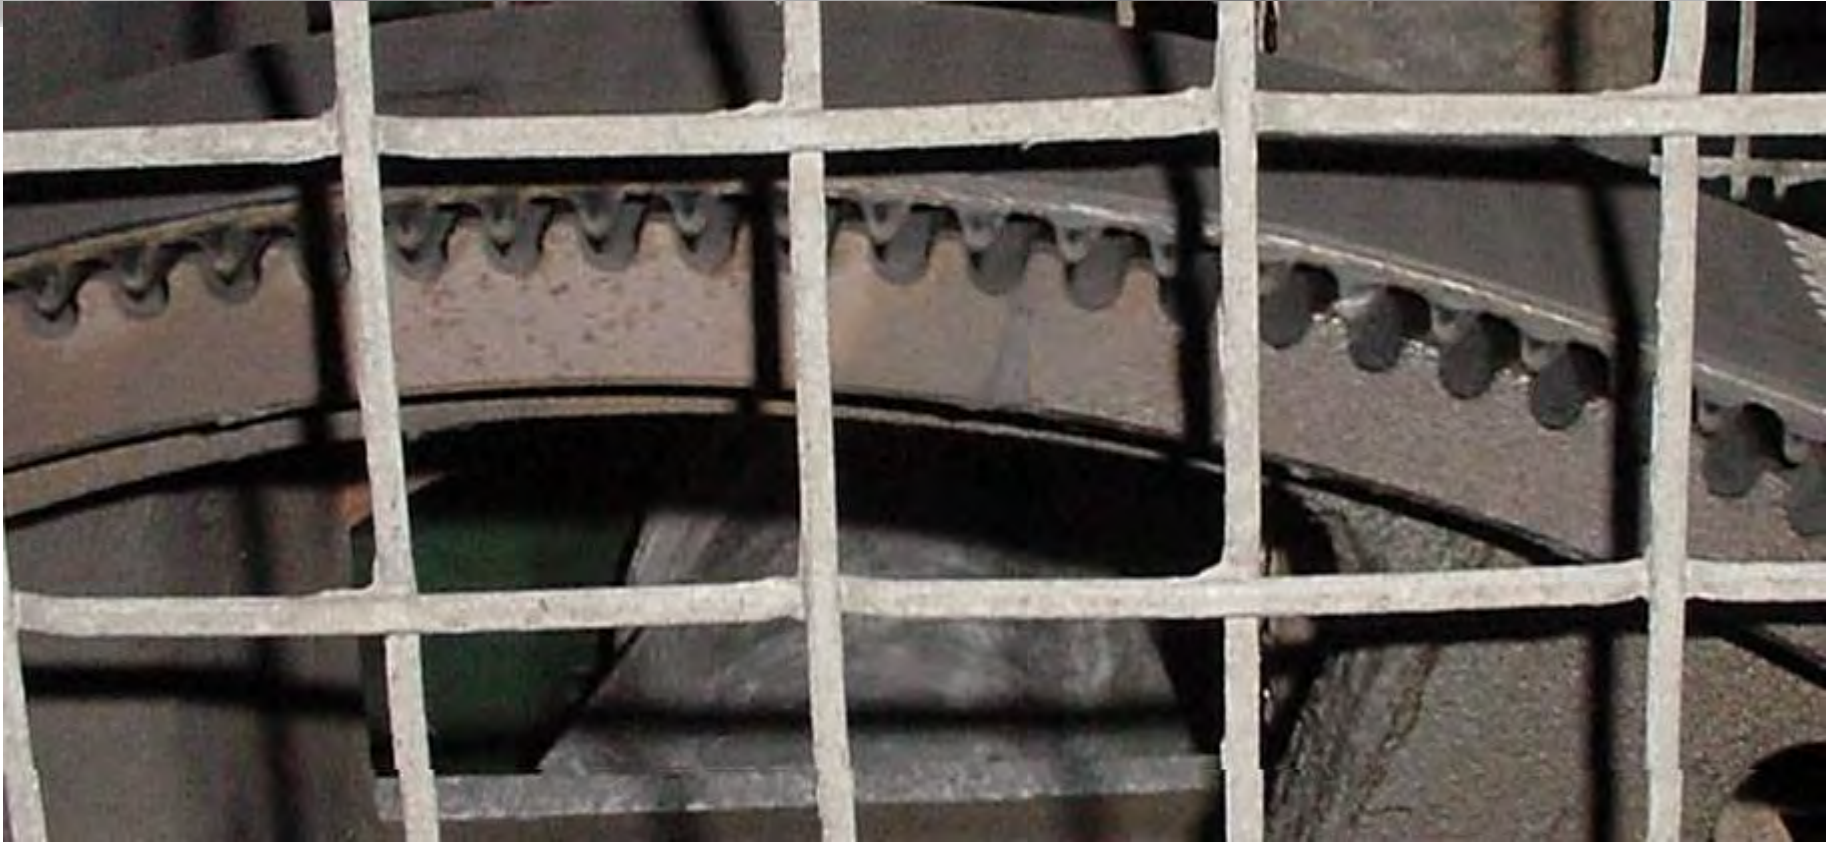
Incorrect Meshing on Driven Pulley

Loaded drive running - photographed with Strobe Light.

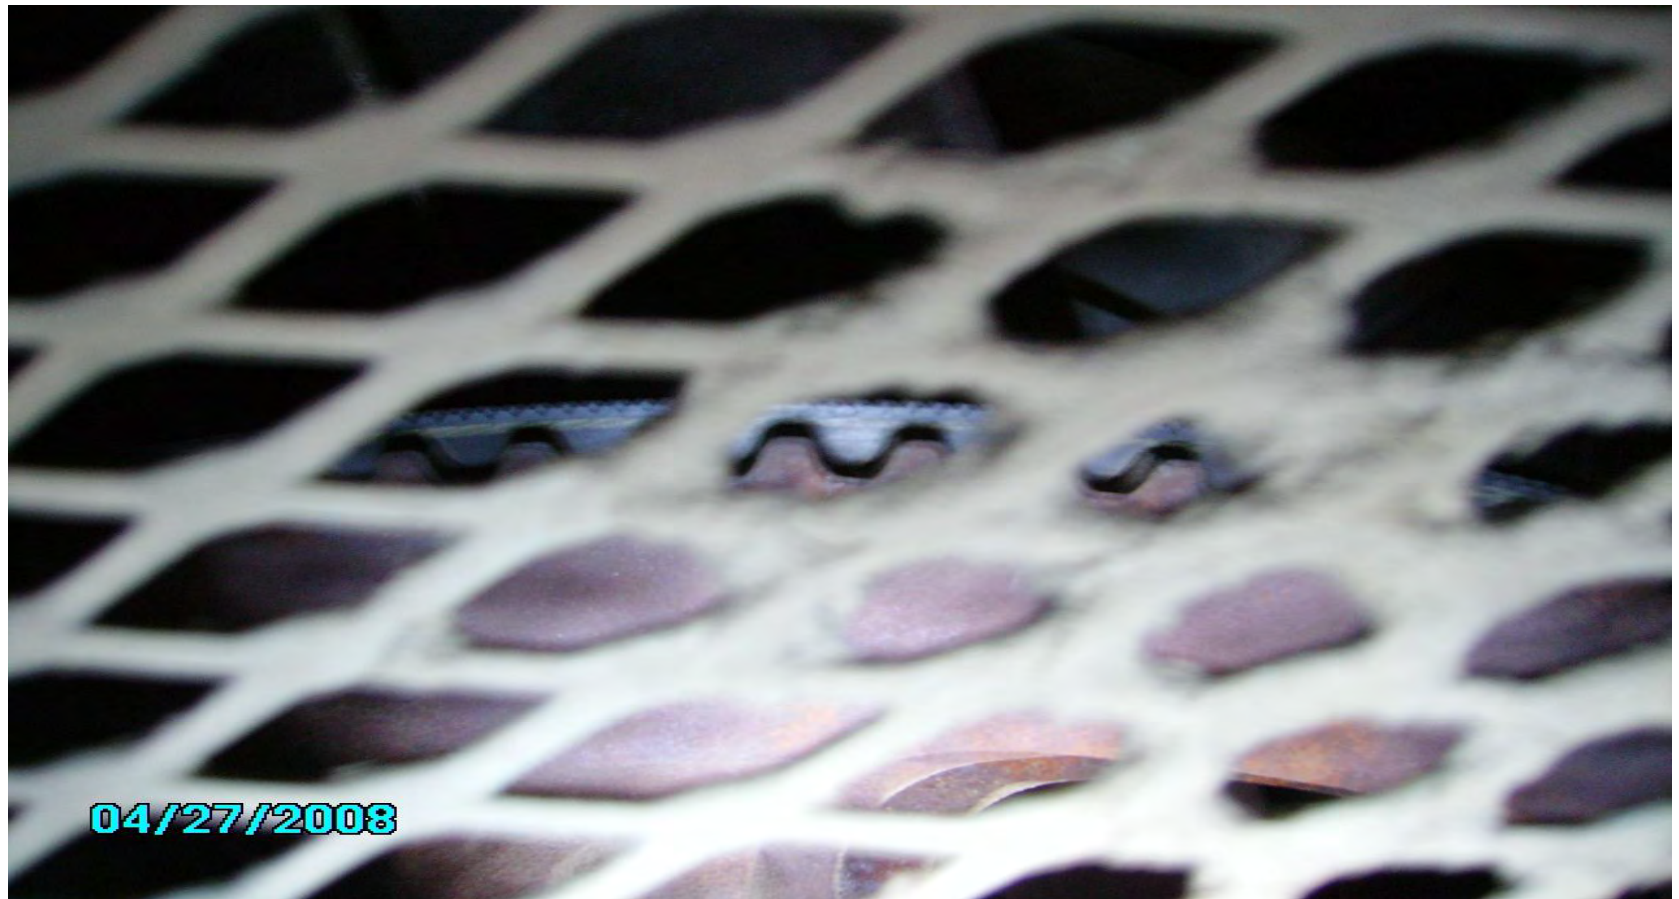
Not too bad but could be better...

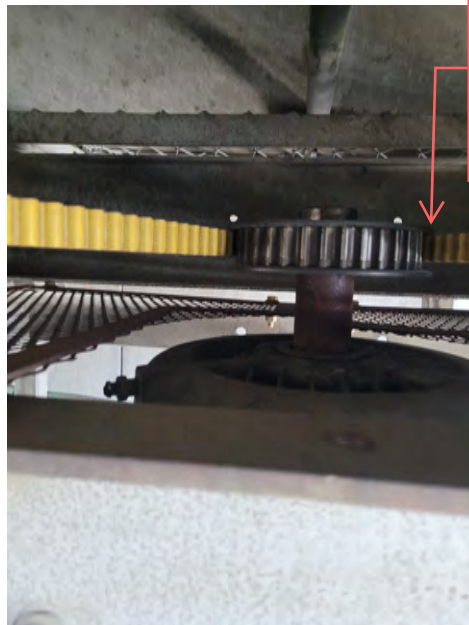
Replaced HTD-85mm wide motor pulley with new Poly-Chain 20mm wide which has twice the HP capacity then the old HTD belt for much less cost and less tracking forces downwards.

See how well the new 20MM fits 85mm fan pulley which is was installed by OEM in 1977. saving customer money.

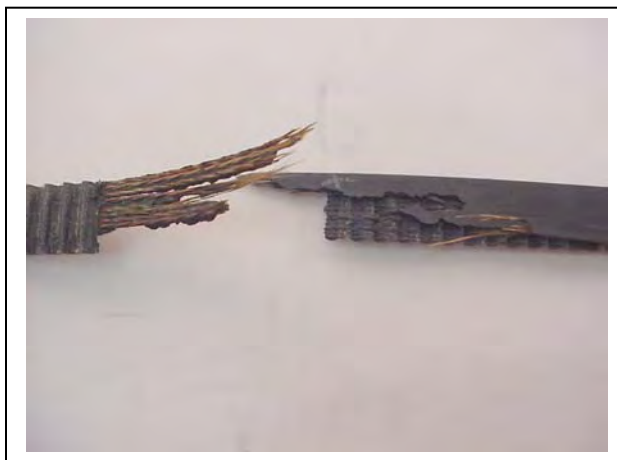
Figure 1 - Normal Tensile Failure

A failure that occurs when a belt reaches its ultimate tensile cord fatigue life, after running for a period of 2 to 3 years, is considered to be normal. Belt tensile failure due to cord fatigue after a long running period is considered to be ideal. Figure 1 illustrates a jagged 45 deg. belt fracture that is typical of tensile cord at the end of its normal fatigue life.

No corrective action is needed for belts performing for a normal 2 to 3 year time period. Belt life can vary significantly from application to application due to numerous factors. Factors affecting belt life include the transmitted power level, the environment, belt installation tension, shaft/sprocket alignment, sprocket condition, and even how the belt was handled prior to and during installation.

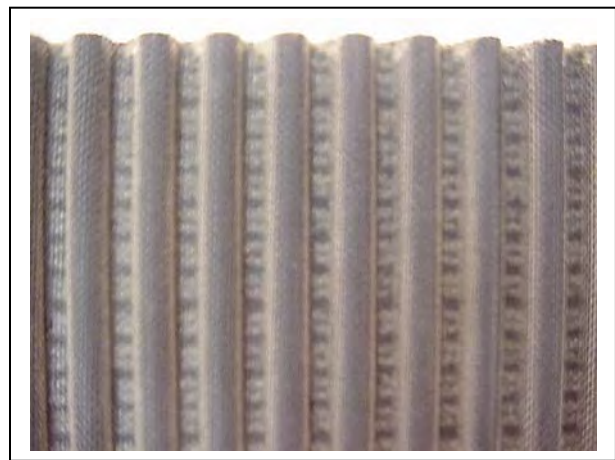
Figure 2 - Frayed Jacket

Synchronous belt teeth can also fail, but is considered to be a non-ideal type of belt failure. After a long period of service, belt teeth may appear to be worn, although they should retain their original size and form. Protruding fibers from the jacket may give belt teeth a fuzzy appearance, as illustrated in Figure 2.

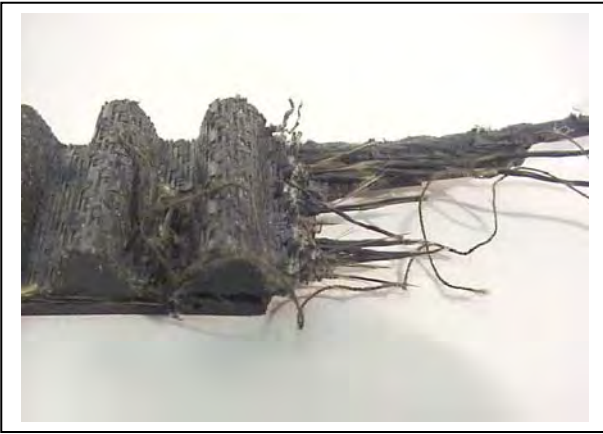
Figure 4 - Shock load Failure

Severe shock loads can result in belt tensile breaks with a ragged and uneven appearance as illustrated in Figure 4. The particular belt teeth engaged in the sprocket at the instant of the shock load may also develop root cracks and/or exhibit tooth shear. If the shock load occurred only once, or was cyclical and repetitious at one specific location around the belt, the remaining belt teeth may appear normal. Figure 5 illustrates how root cracks caused by shock loading can propagate through the teeth. Cracks forming at the tooth roots sometimes move towards the tooth tips. Teeth containing multiple cracks may then shear, leaving only a portion of the tooth behind.

The shock loads generated by the driven equipment may be an inherent part of system operation, or may result from an occasional harsh condition such as jamming. If the drive shock loads cannot be eliminated, the belt tensile strength may need to be increased or the synchronous belt drive replaced with a more forgiving V-belt drive system capable of intermittent slip.

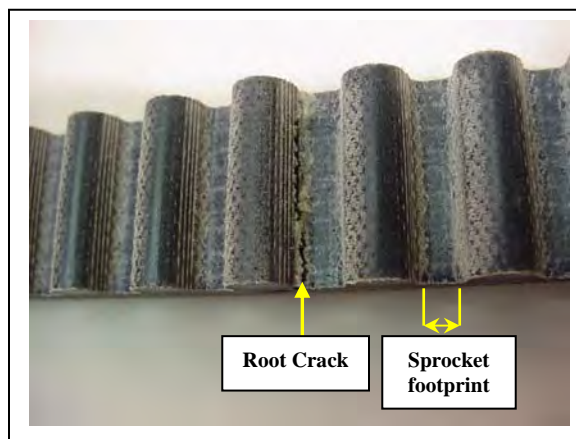
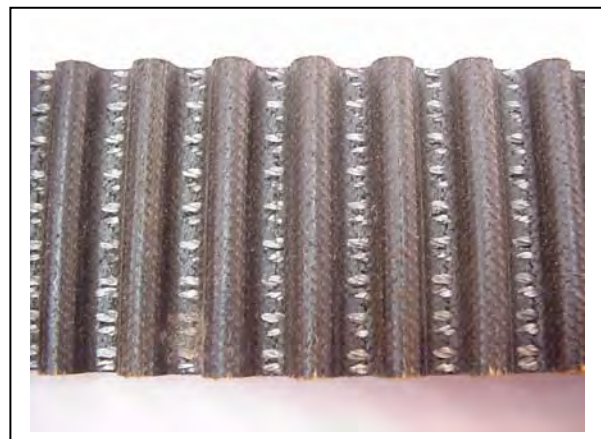
Applying excessive installation tension to a synchronous belt may result in belt tooth shear or even a tensile break. Many belts that have been excessively tensioned show visible signs that sprockets have worn the belt land areas. Figure 1 illustrates a belt with crushed land areas and a crack that formed at the root of the belt tooth. A root crack will often propagate down to the tensile member and travel to the next root crack. Individual belt teeth will then separate from the body of the belt and often fall off. Figure 2 illustrates a belt that had been over tensioned on large sprockets. High belt land pressures caused excessive belt land area wear, ultimately revealing individual tensile cords. In order to prevent belt wear problems like these, proper belt installation tension levels must be determined and set accurately.

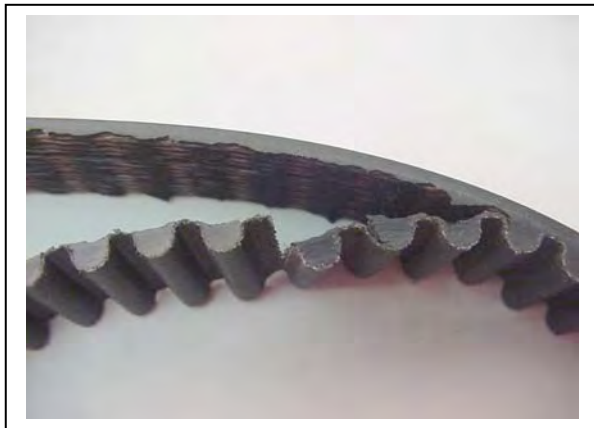
Applying insufficient installation tension to belts operating on moderately to heavily loaded drive systems may also result in premature failures. A common belt failure mode resulting from insufficient belt installation tension is referred to as tooth rotation. Belt tooth rotation can occur as belt teeth climb out of their respective sprocket grooves (self tensioning) and drive loads are

no longer applied at their roots. Drive loads applied further down the belt tooth flanks cause the belt teeth to bend (like a diving board), and “rotate”. Belt tooth rotation can result in rubber tearing at the base of the belt teeth along the tensile member. As rubber tearing propagates, belt teeth often begin to separate from the belt body in strips, as illustrated in Figure 3. Failures due to excessive tooth rotation may resemble failures caused by insufficient rubber adhesion to the tensile cords. Failures from insufficient rubber adhesion, however, leave the exposed tensile members clean where the belt teeth were once located unlike tooth rotation failures.

As belt teeth climb out of their respective sprocket grooves to self tension, belt ratcheting or tooth jumping may occur before rubber tearing and belt tooth separation occurs. Belt tensile cord damage resulting from ratcheting can cause premature belt tensile failures. These tensile failures may resemble crimp type breaks (straight and clean) as well as shock load type breaks (jagged and angled). If belt ratcheting does not occur and belts continue to operate while self tensioning, excessive belt tooth wear often occurs. This tooth wear is referred to as “hook wear” and results from improper belt tooth meshing with the sprockets, Figure 4. Hook wear type belt failures result from insufficient belt installation tension, and from weak drive structures that allow center distance flexing while the drive system is under load.

Increasing belt installation tension levels generally prevents premature belt failures due to tooth rotation and hook wear. If increasing the belt installation tension level does not prevent this type of failure, the drive structure may not be rigid enough to prevent deflection. Added structural support may be necessary to improve belt performance. If it is not practical to increase belt installation tension levels, increasing the sprocket diameters will allow higher drive loads to be transmitted with less belt tension.

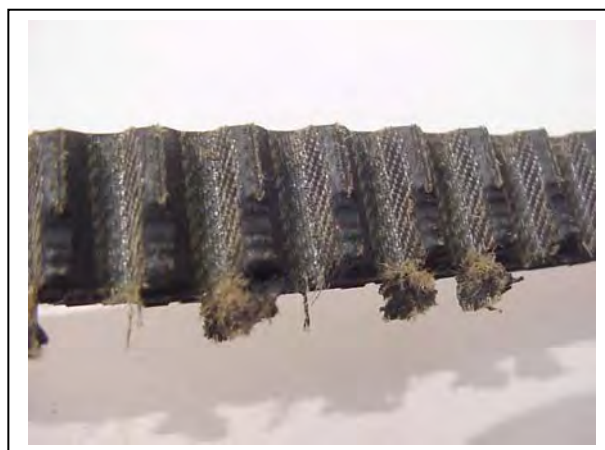
Figure 1 – Angular Misalignment

Belts operating on drives with angular shaft misalignment or tapered sprockets often exhibit an uneven wear pattern across the belt tooth flanks and uneven compaction in the land areas (in-between belt teeth) due to the uneven application of load to the belt. Belt failures often occur from tooth root cracks or tears initiating on the side of the belt that is carrying the highest tension and propagating across the belt width, ultimately resulting in tooth shear. One edge of the belt may also show significant wear due to high tracking force, and may even roll up or attempt to climb the sprocket flange(s). Figure 1 shows extreme belt edge wear from a high tracking force.

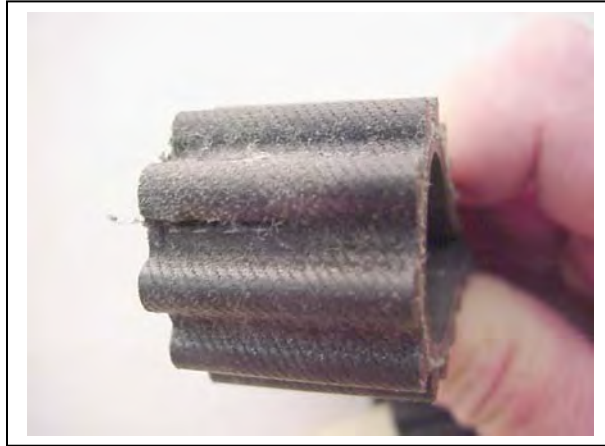
Figure 2 – Parallel Misalignment

Belts operating on flanged sprockets with parallel misalignment (offset sprockets) may exhibit excessive belt edge wear on both edges if the belt is pinched between opposite flanges. Belt failures may then occur by tooth root cracks or tears initiating from both edges of the belt. These tears may eventually extend across the entire width of the belt, resulting in tooth shear.

belt remaining engaged with the non-flanged sprocket(s) will carry the full operating load and may develop a concentrated area of wear after running this way for a period of time. Figure 2 shows concentrated wear across the majority of the belt tooth face with a portion relatively unworn. A root crack has also developed below the worn area. This may ultimately result in premature belt failure due to either tensile or tooth fatigue.

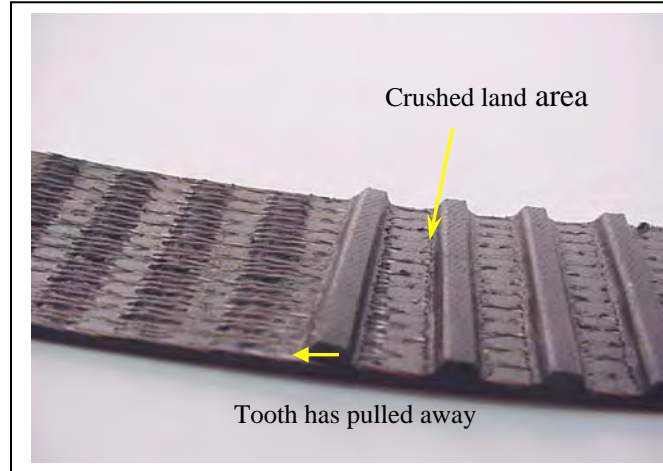
Figure 6 - Sprocket Run-Out

Belts operating on sprockets with radial run out are subjected to a cyclic rise and fall in belt tension as the sprockets rotate. The greater the run out, the higher the peak belt tension grows. Belts subjected to significant cyclic peak tensions exhibit land areas with a crushed appearance. Crushed land areas and tooth shear are both visible in Figure 6. A crushed land area condition may appear similar to belts operating on moderate size sprockets under excessively high tensions. Belts subjected to extreme cyclic belt tension variations often fail from either tooth shear or tensile break.

Excessive sprocket run out is most often observed when sprockets are mounted improperly on bushings, or when minimum plain bore sprockets are improperly re-bored and mounted. Sprocket re-boring instructions and shaft / bore fit recommendations are published in the Poly Chain GT2 Drive Design Manual (17595) and the PowerGrip GT2 Drive Design Manual (17195).

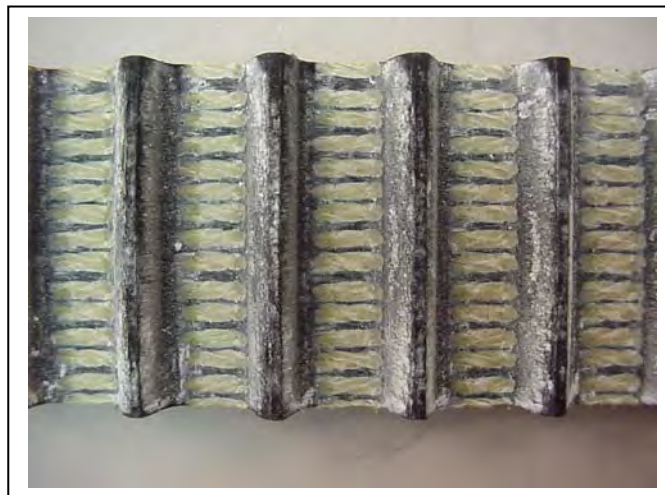
Figure 1- Belt Wear From Abrasive Atmosphere

Belts operating in abrasive atmospheres on applications like foundry shakers, taconite processing equipment, and phosphate mining conveyors, often exhibit a high degree of belt land and tooth flank wear. Worn areas frequently have a polished appearance. Figure 1 illustrates a severely worn Poly Chain GT2 belt that ran in a highly abrasive environment. Sprocket wear is generally rapid in abrasive environments; therefore sprockets should be replaced along with belts. To extend the life of belts and sprockets, a sealed guard that is pressurized with clean air can be installed to help keep out abrasive dust and contaminants.
