THERMAL GROWTH ISSUES AND SOLUTIONS FOR SHAFT COUPLINGS

Thermal Growth Issues and Solutions for Shaft Couplings

Nick Agius, National Rotating Equipment/ACHE Product Specialist, Motion Canada

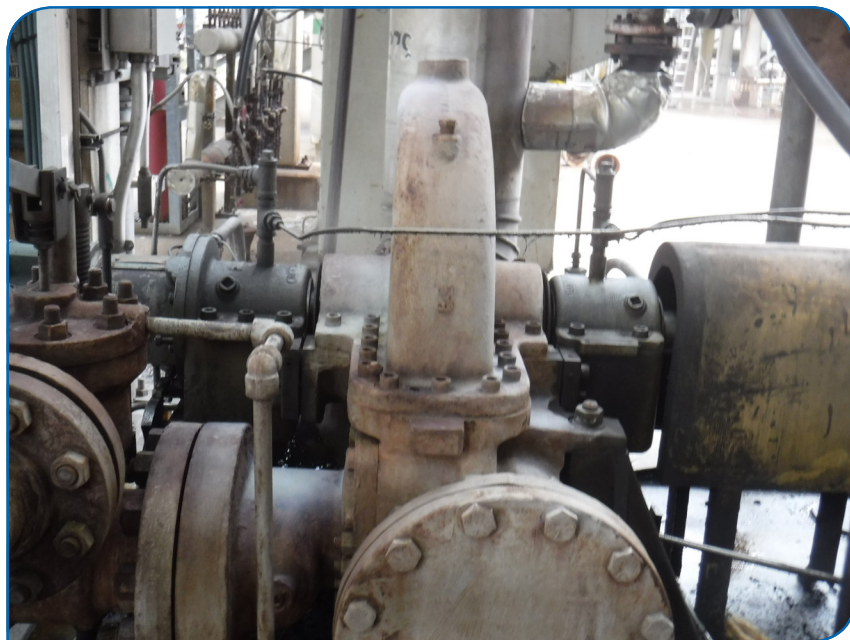
Outdoor boiler feed pump at a refinery in Canada with thermal growth issues due to seasonal pipe strain.
